4 WTC 4, 5, and 6

4.1 Design and Construction Features

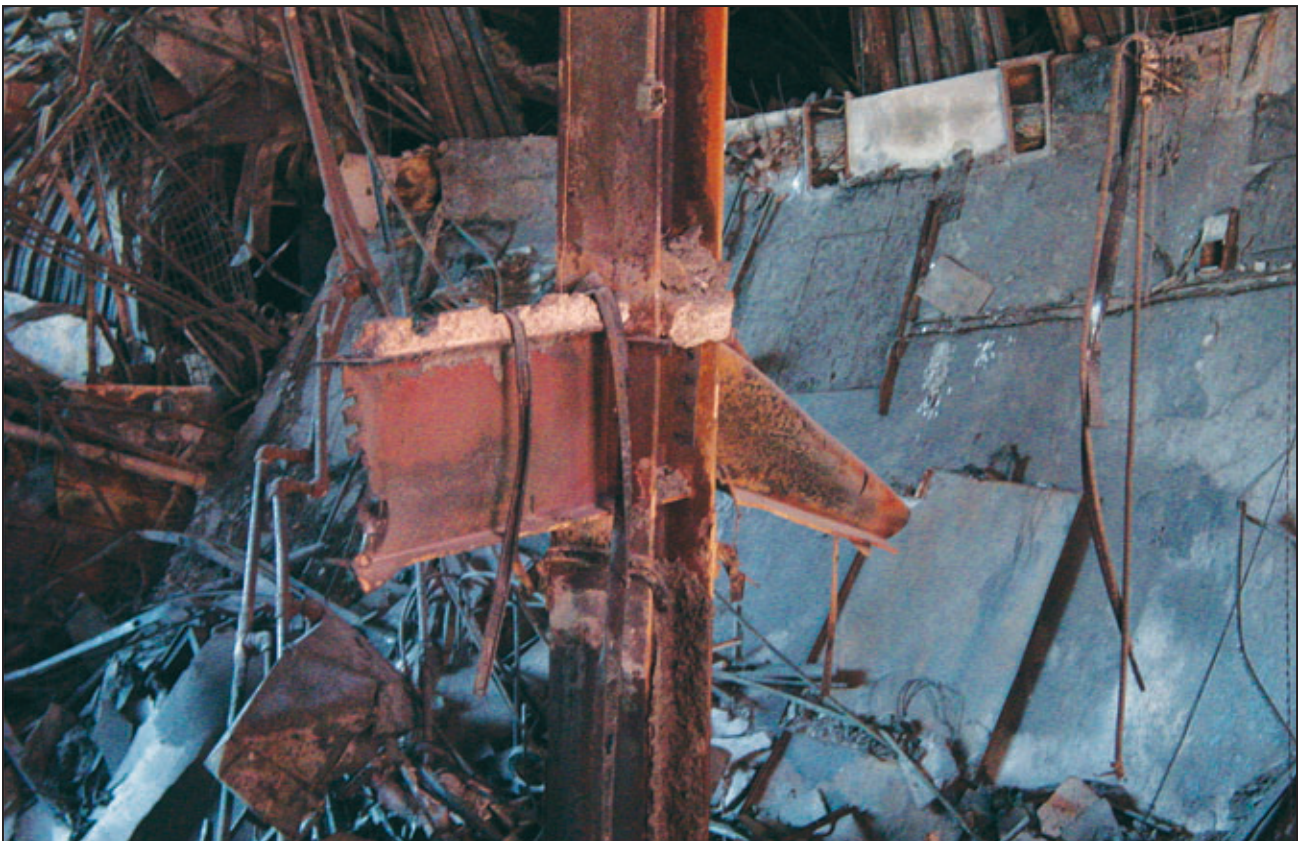
Two areas in WTC 5 experienced local collapse under an intact portion of the roof. Although there was debris impact near this area, the symmetrical nature of the collapse strongly suggests that the failures were due to the uncontrolled fires. This is supported by the observation that the columns in this area remained straight and freestanding (see Figure 4-18). This local collapse appeared to have begun at the field connection where beams were connected to shop-fabricated beam stubs and column assemblies as illustrated in Figures 4-19, 4-20, and 4-21.

Figure 4-21 Internal collapsed area in WTC 5 with closeup of connection failure at column tree.

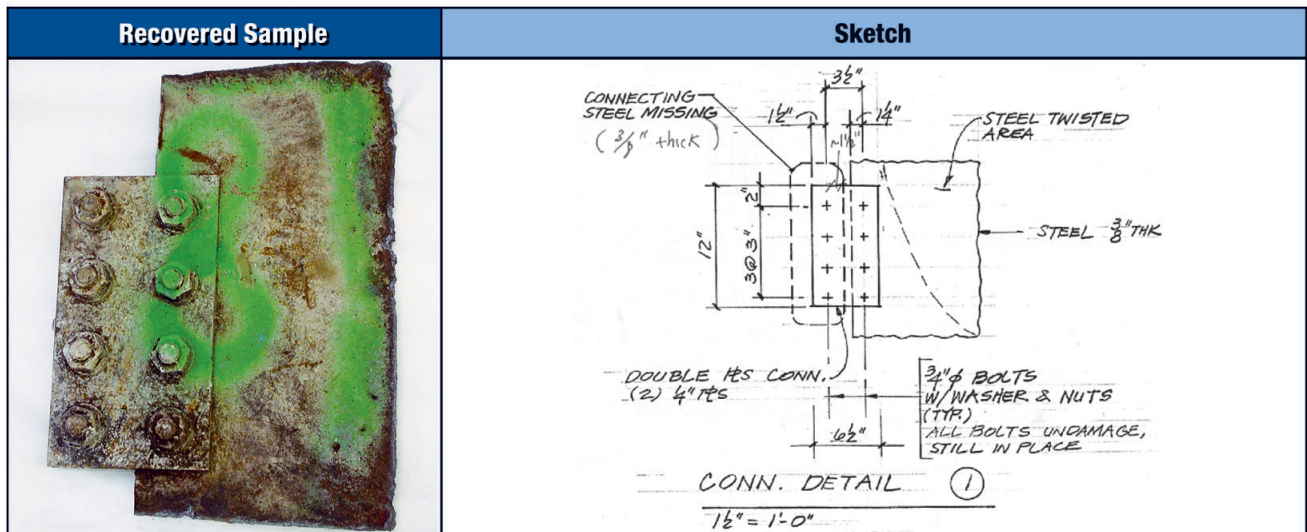
Recovered From: WTC 5, 8th Floor

Failure Mode: Web tear-out at bolts

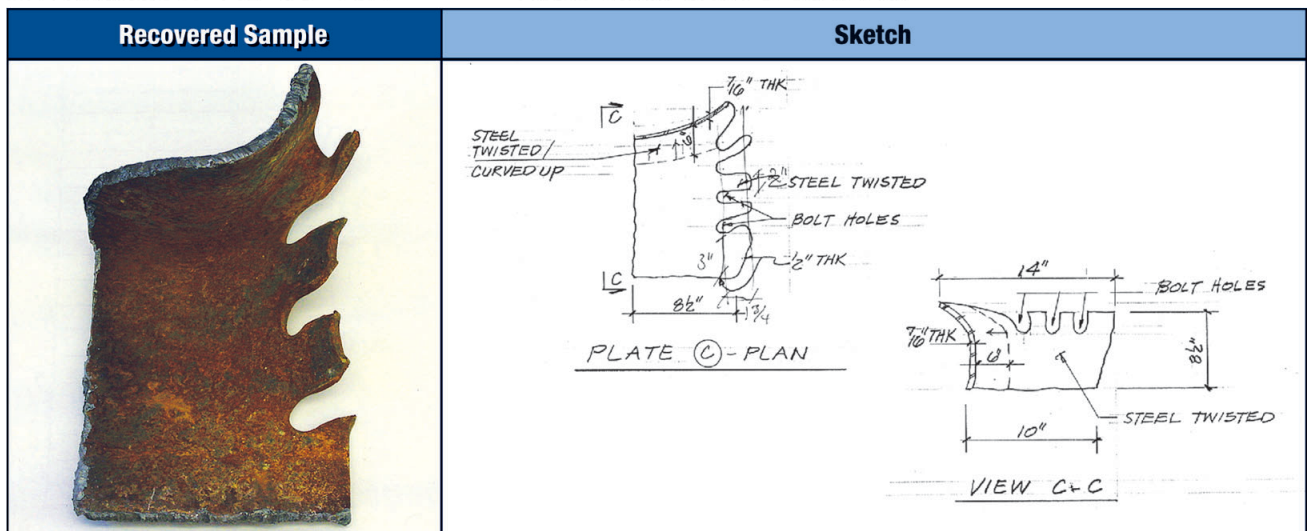
Recovered From: WTC 5, 7th Floor

Failure Mode: Web tear-out at bolts

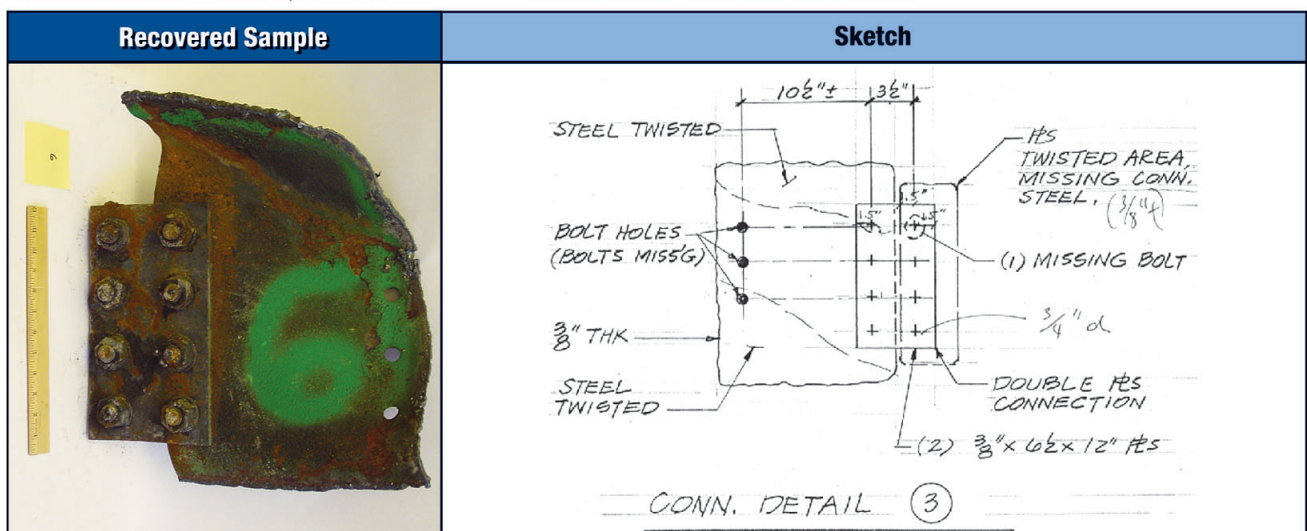
Recovered From: WTC 5, 6th Floor

Failure Mode: Web tear-out at bolts

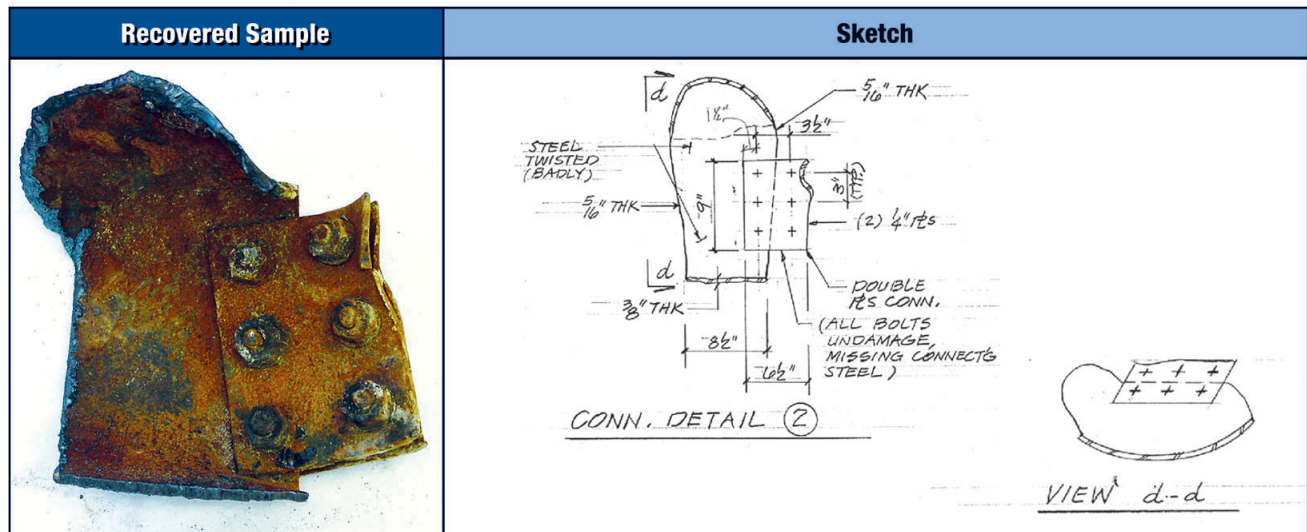
Recovered From: WTC 5, 6th Floor

Failure Mode: Web tear-out at bolts

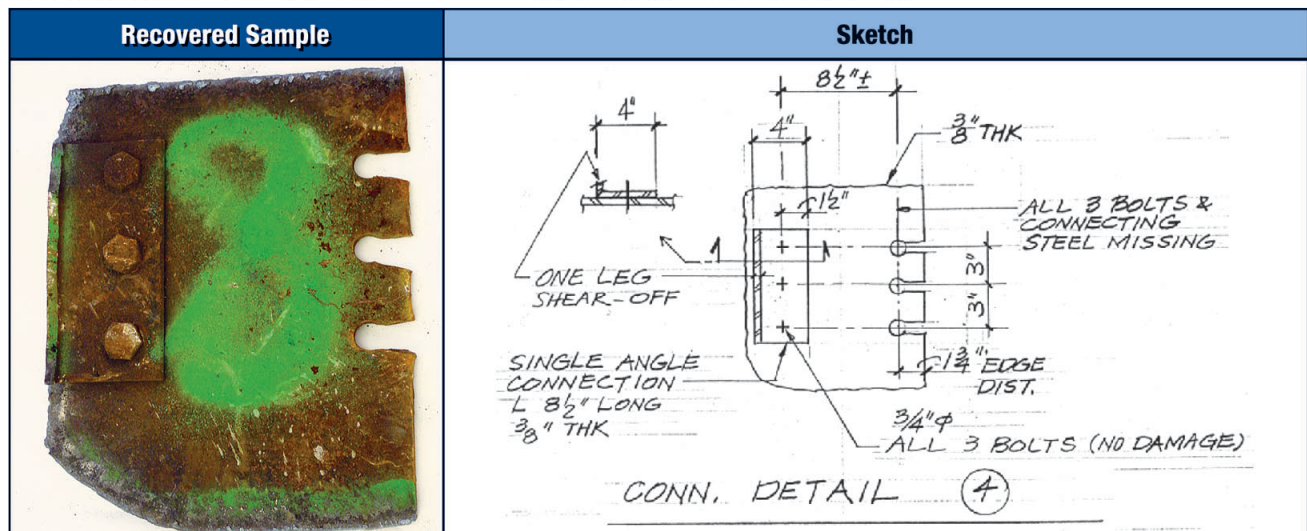
Recovered From: WTC 5, 8th Floor

Failure Mode: Plate tear-out at bolts

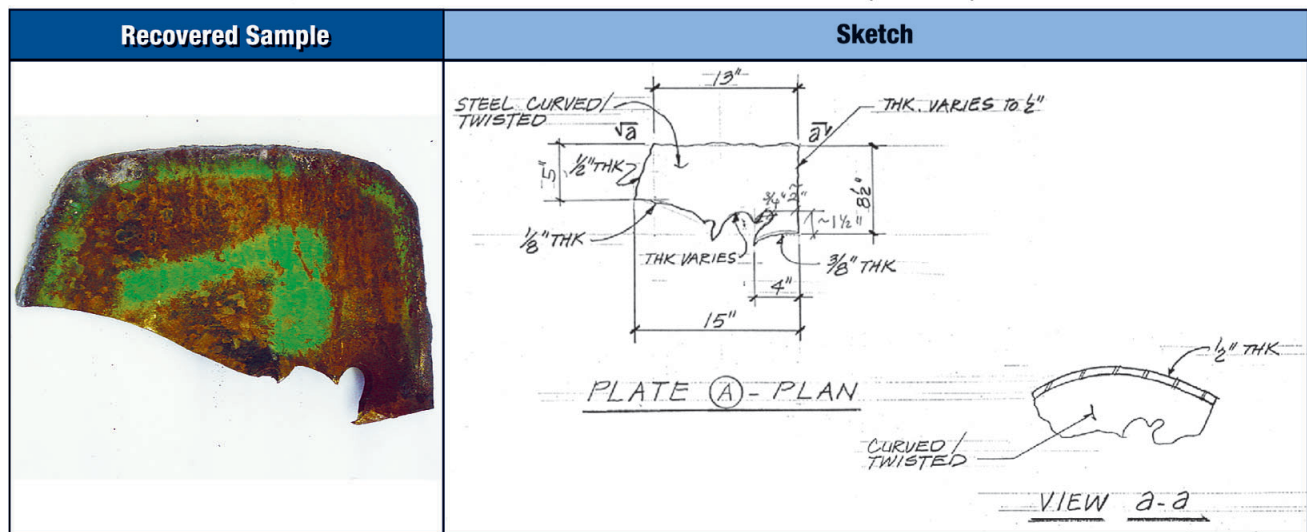
Recovered From: WTC 5, 7th Floor

Failure Mode: Connection web plate or splice block shear

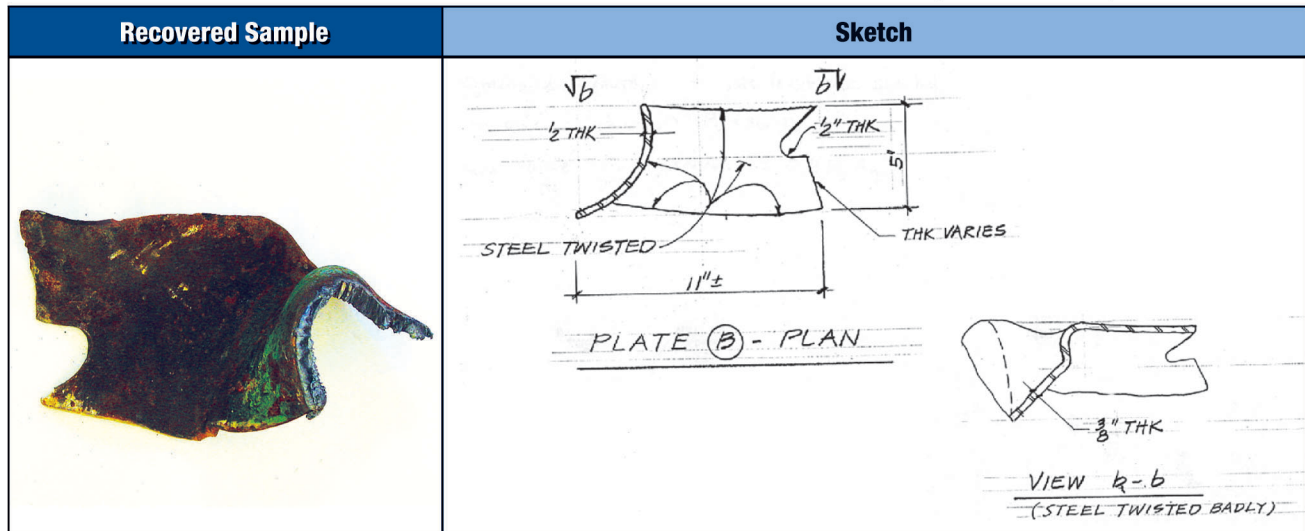
Recovered From: WTC 5, Floor undetermined

Failure Mode: Column buckling due to heat exposure
